Manhole Inspection Summary

Manhole # S37W1_003MH

Insp Date: **5/13/08 11:46 AM**

Location Address: **3570 S. Hanover St.**

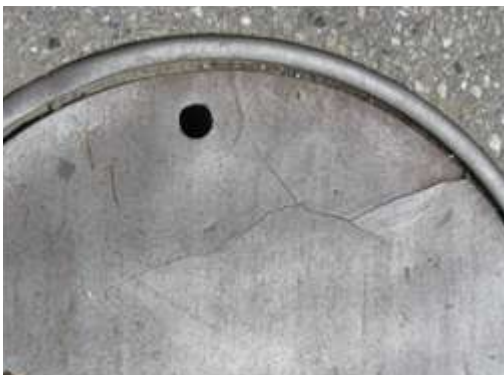
Defect 1

Inspection ☐ Is Incomplete Rating: **5) Immediate Attention Required**

Comments **Cover cracked**

Condition: **Cracked**

Cracked Cover

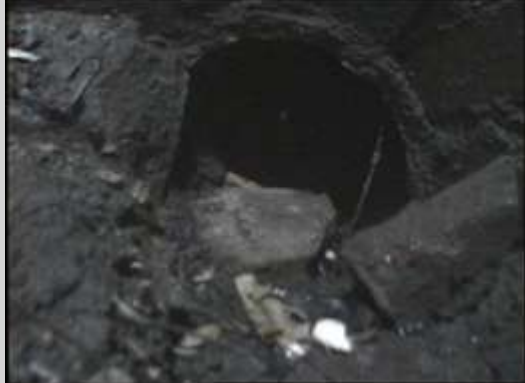
12 O'Clock Outflow

8 in. Circular Gravity Sewer
Pipe Out @ 12 O'Clock

Deposits: ☐ None ☐ Mud ☐ Sludge ☒ **Debris** ☐ Grease

Silt Depth: **2** (in.) Deposits Extent: **Medium**
